# Flood Hazard Assessment Report
# Falls Gulch, Larimer County, Colorado

**January 16, 2013**

**Purpose:** The purpose of this report is to summarize the findings of our (NRCS) site evaluation of the Falls Gulch Area in relation to potential flooding that could be expected from the Falls Gulch Watershed after the High Park fire.

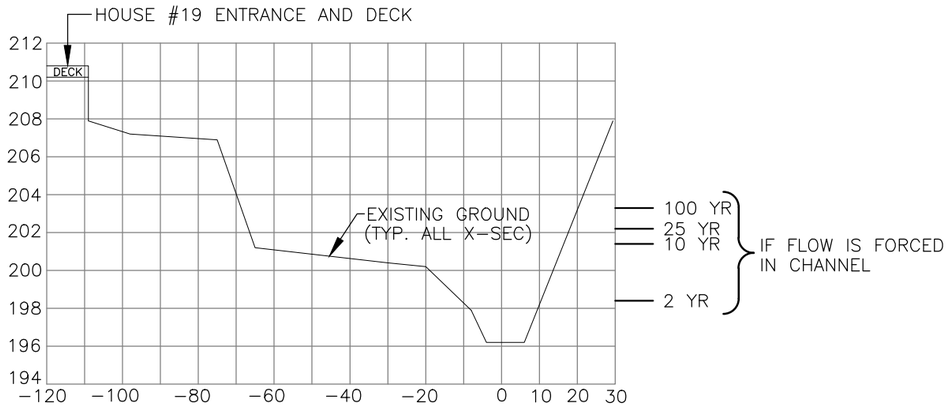
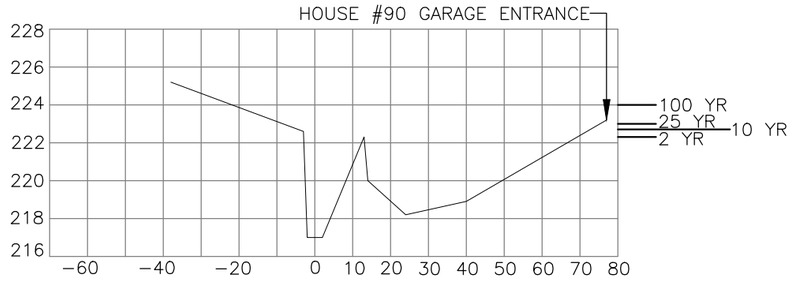
The channel crosses from the west side of the gulch to the east side between house numbers 50 and 57. Improving the channel at the road crossing, near cross section 4+35, provides the best opportunity to direct out of channel flows back into the channel. Currently, flows are conducted under the road through a 3.3 foot diameter 43 foot long culvert. The headwall on the upstream side is made up of boulders. There is a wooden headwall on the downstream side of the culvert. The space between the headwalls is filled to provide a rather wide crossing. The culvert has a capacity of 70 cubic feet per second (cfs). This is not enough capacity to conduct the flow from even a moderate post

**X-SEC 2+14**
(789.89 S.F.)

**X-SEC 5+46**
(266.67 S.F.)

**X-SEC 2+80**
(446.88 S.F.)

**X-SEC 7+20**
(339.74 S.F.)

**X-SEC 4+35**
(167.61 S.F.)

**X-SEC 9+00**
(420.20 S.F.)

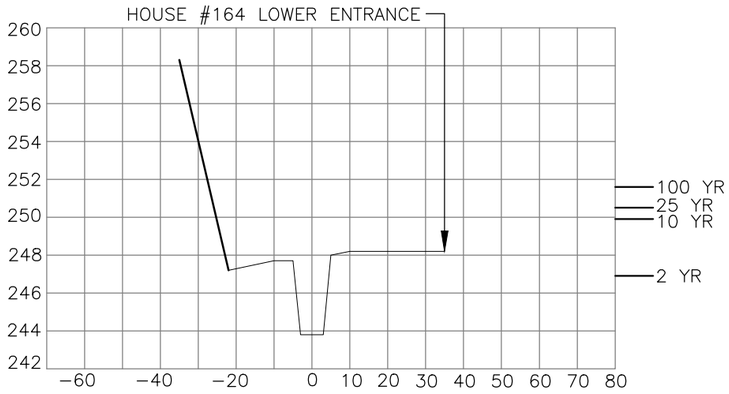
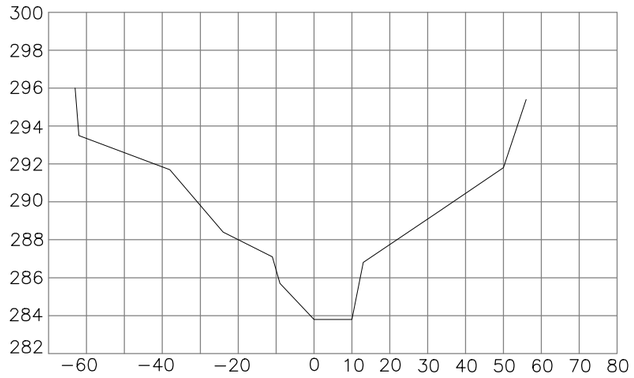
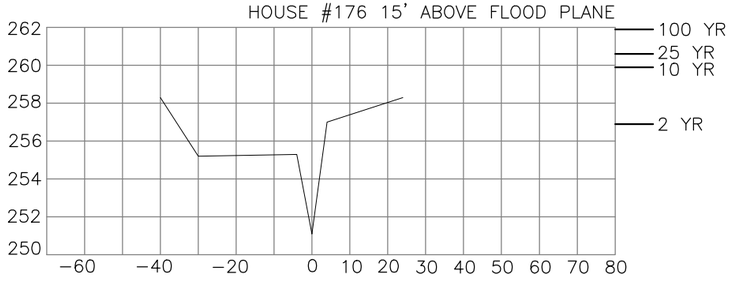
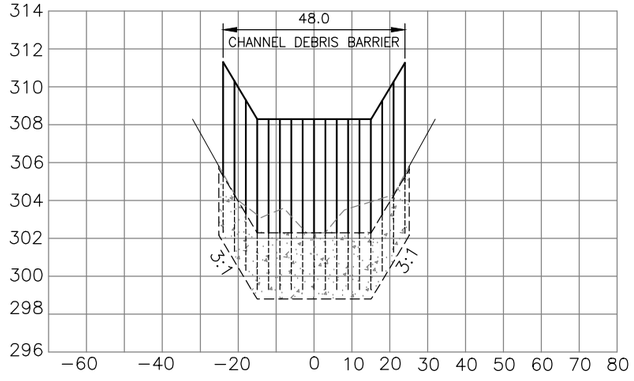
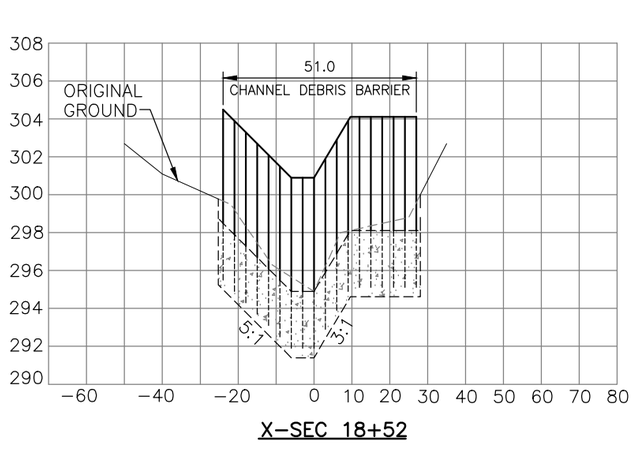
The channel is restricted between station 10+50 and 14+00, where houses, or lots, numbered 164, 176 and 200 are located. Flood water in excess of the channel's capacity will be forced onto the roadway and properties near or below the road level. This is especially true at culverts where capacity is further reduced. Measures such as grading the road slightly toward the channel and constructing water bars would serve to redirect the flow back into the channel thus limiting damage to the roadway. The shed recently placed on lot number 200 is quite vulnerable to flood flows. If dislodged, it would likely become an obstruction to flow at some point downstream and contribute directly or indirectly to additional flood damage. Sandbags should be UV resistant.

At house number 164, station 10+50, a concrete block barrier placed near the edge of the channel from the large boulders to the driveway or even part way across the driveway would help to direct flow downstream. Another potential alignment for a concrete block wall is along the stone wall in front of the house from the concrete pad at the southwest corner of the house to the entrance near the garage to protect the foundation. A sandbag wall placed along the existing stone wall is another option since variability in the slope of the ground and the curvature of the stone wall make the placement of concrete blocks difficult and prone to gaps. The sandbags would conform to the slope and the shape of the stone wall and the wall would support the sandbags.

X–SEC 10+52
(48.49 S.F.)

X–SEC 16+30
(738.92 S.F.)

X–SEC 11+95
(145.20 S.F.)

X–SEC 18+04

X–SEC 14+00
(406.97 S.F.)

X–SEC 18+52

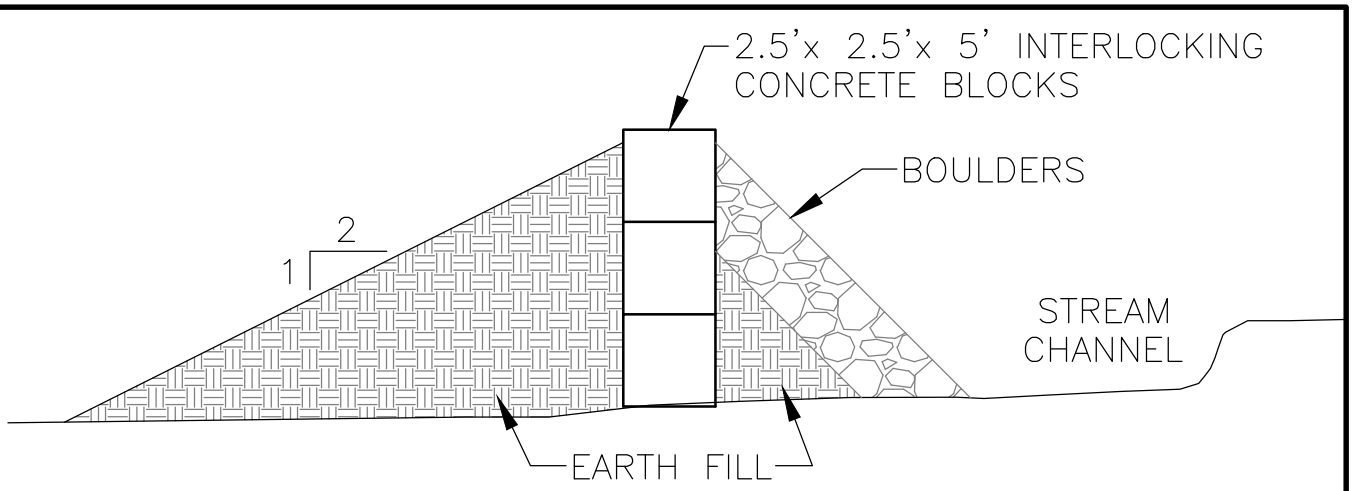
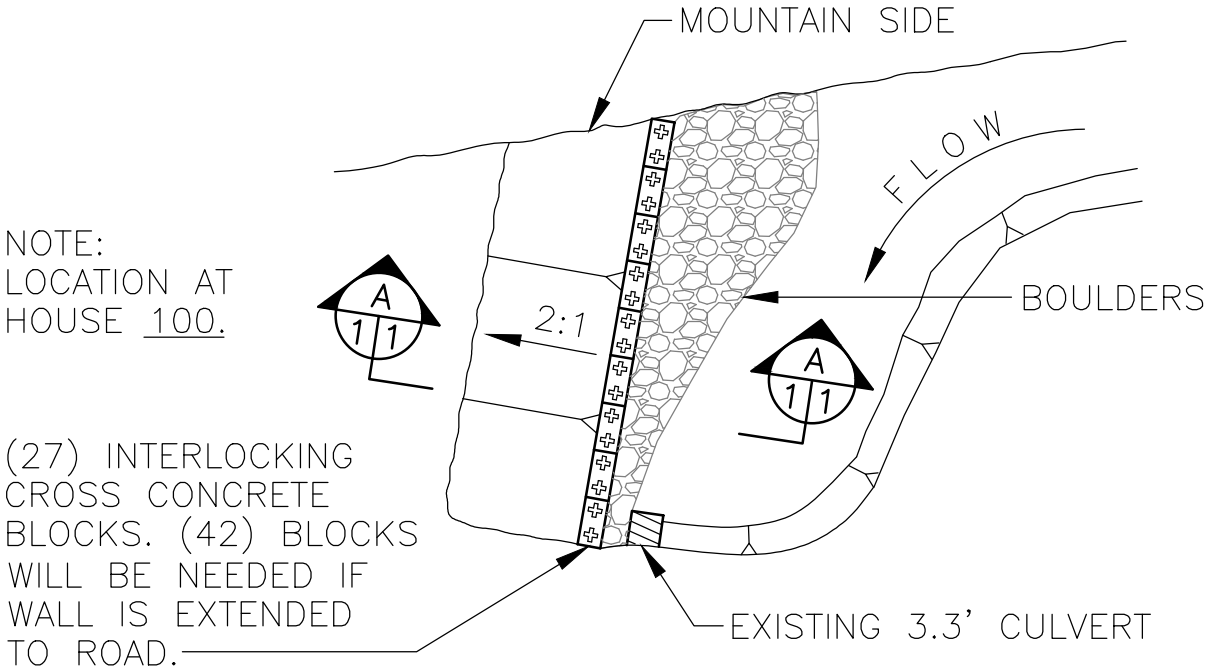
## SECTION A–A
NO SCALE

The culvert adjacent to house number 100, near station 7+75, is not large enough to pass even a moderate flow event. Water backed up behind the culvert will flow around the culvert and likely over the bank and down the slope into the low area between the channel and the house. The history of culverts in this location indicates the culvert is likely to be plugged by sediment resulting in increased flow around the culvert and over the bank. The culvert could be washed out.

The constructed bank upstream of the culvert is made up of gravelly and sandy material that is prone to erosion. The bank is at a bend in the channel and subject to the force of the current during high flows. This could lead to failure of the bank.

NOTE:
LOCATION AT HOUSE 100.

(27) INTERLOCKING CROSS CONCRETE BLOCKS. (42) BLOCKS WILL BE NEEDED IF WALL IS EXTENDED TO ROAD.

If the culvert is kept at this location, flood protection could be provided by constructing a concrete block wall. A conceptual drawing of a wall at this location shows an alignment from the mountainside to 5 feet past the culvert opening, 45 feet. Extending the wall another 25 feet along the culvert to the road might be considered to provide additional protection for the home and property. The drawing shows the base of the concrete block wall at or below the level of the stream bed. The wall shown is three blocks high and buttressed on the front side by a wedge of coarse stone with large boulders along the base to direct the current around the curve in the channel and resist erosion. The wall must be supported on the back side by a wedge of earthen material no steeper than a 2:1 slope. If concrete blocks are placed <u>on</u> the existing bank, it is essential to protect the bank from erosion with coarse stone and large boulders grouted in place to prevent the block wall from being undermined and collapsing. The design option selected by the community for a structure at this location should be reviewed by a qualified engineer. If the culvert fills or is washed out, water will still flow toward the house but would be farther downstream than if the bank upstream of the culvert were to fail. See the note on concrete block placement below.
